**Flood Control Project Maintenance
Levee Inspections**

Fall 2015 Levee Maintenance Deficiency Summary Report

Sacramento River Basin

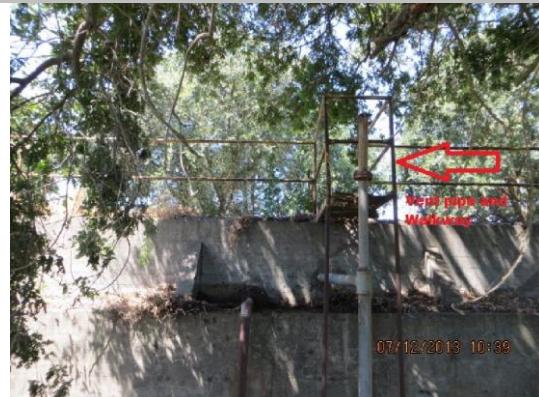
Photo 1 of 3 : UCIP_FA_2015_1469.jpg

LM Start	0.74	Rating **	M	Issue No.	45									
LM End	0.74	Issue Type +	En	Location *	LS									
Category	Supplemental			GPS Latitude/Longitude										
				Start	End									
Item	DWR UCIP Field Study			38.423429 °	38.423429 °									
				-121.529491 °	-121.529491 °									
DWR ID														
Action/Comments														
Inspector Comments: FS_ID:41070 DS_ID:22811 EP_NO: 10514 FS_HLM: 0.737 Repair Type: Non-Urgent Crossing Status: Found UCIP Comments: Need to determine disposition of pipe and if abandoned, it should be done so properly. FIELD_STRUCT_DESC: 2 of 3: 4.5-inch galvanized iron irrigation pipe through the levee 3.0 feet below the crown. Slant pump, steel walkway, and steel vent pipe on the waterward slope. Pipe has shutoff valve off LS toe (Permit No. 10514, 1974). FS Date: 07/12/2013

Pipe, walkway, and vent on WS shoulder.

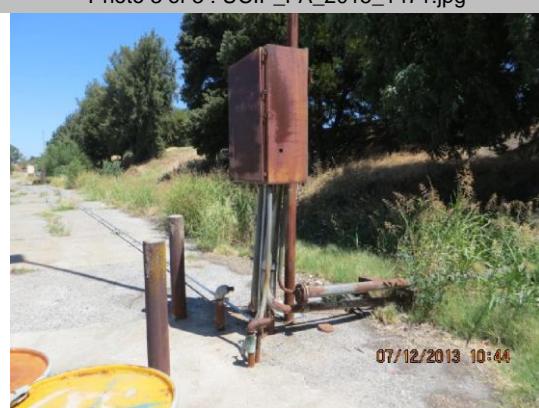
Pipe with cap or gate valve on end off LS toe.

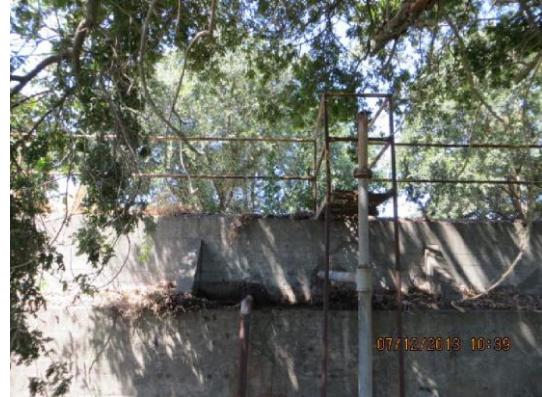
Photo 1 of 3 : UCIP_FA_2015_0548.jpg

LM Start	0.74	Rating **	M	Issue No.	46							
LM End	0.74	Issue Type +	En	Location *	LS							
Category	Supplemental			GPS Latitude/Longitude								
				Start	End							
Item	DWR UCIP Field Study			38.423429 °	38.423429 °							
				-121.529491 °	-121.529491 °							
DWR ID												
Action/Comments												
Inspector Comments: FS_ID:41556 DS_ID:22794 EP_NO: N/A FS_HLM: 0.737 Repair Type: Non-Urgent Crossing Status: Found

4.5-inch pipe at headwall on WS slope.

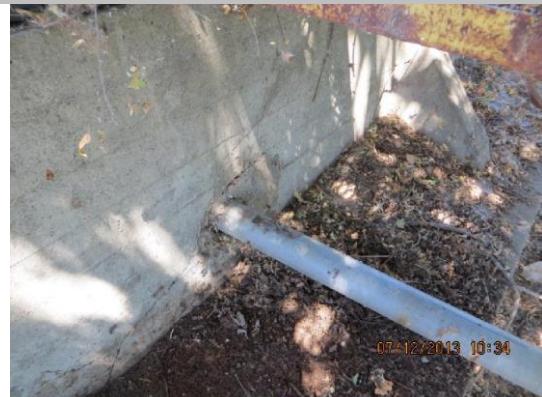
Photo 2 of 3 : UCIP_FA_2015_0549.jpg

4.5-inch pipe at headwall on WS slope.

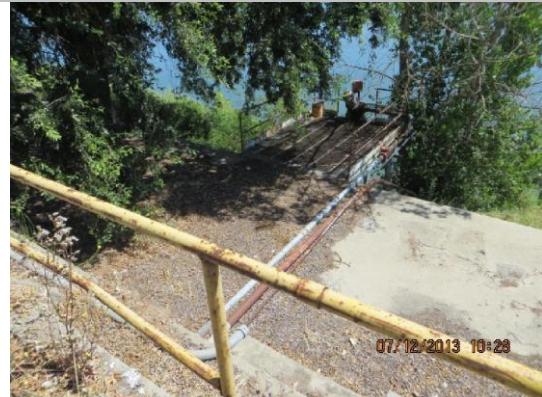
Photo 3 of 3 : UCIP_FA_2015_0550.jpg

Pump on pier for 4.5-inch pipe sleeved through 10-inch.

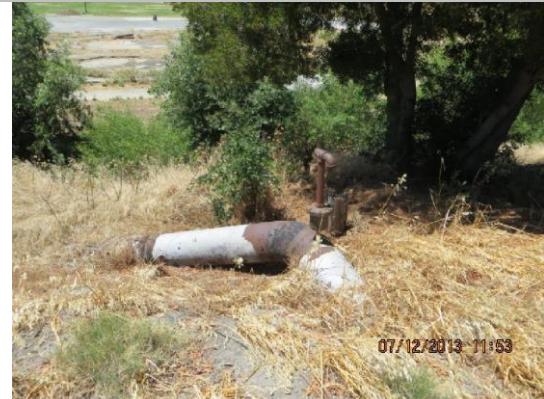
Photo 1 of 2 : UCIP_FA_2015_1267.jpg

LM Start	0.81	Rating **	M	Issue No.	47																	
LM End	0.81	Issue Type +	En	Location *	LS																	
Category	Supplemental				GPS Latitude/Longitude																	
					Start	End																
Item	DWR UCIP Field Study				38.424399 °	38.424399 °																
					-121.530178 °	-121.530178 °																
DWR ID																						
Action/Comments																						
Inspector Comments: FS_ID:16389 DS_ID:22797 EP_NO: 1624 FS_HLM: 0.814 Repair Type: Non-Urgent Crossing Status: Found UCIP Comments: Pipe abandoned and should be done so properly. FIELD_STRUCT_DESC: 16-inch steel irrigation pipe through the levee 3.0 feet below the crown. Pump and pile structure removed from waterside toe. Steel plate welded over WS end (Permit No. 1624, 1959). Replaces an existing facility north of this location. FS Date: 07/12/2013

Pipe and vent/siphon breaker on LS slope.

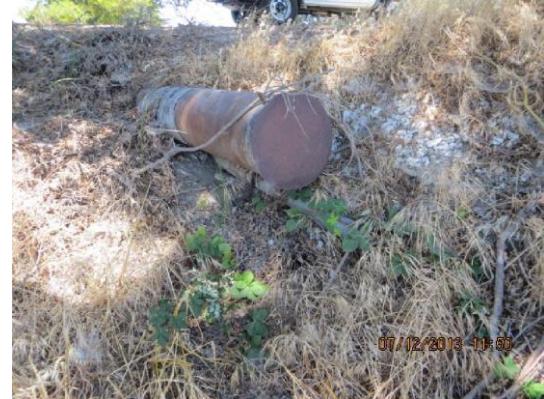
Photo 2 of 2 : UCIP_FA_2015_1276.jpg

Pipe with steel plate welded over WS end.

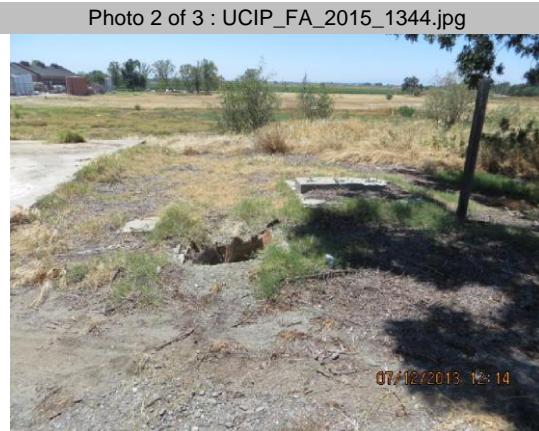
LM Start	0.90	Rating **	M	Issue No.	48 (cont)									
LM End	0.90	Issue Type +	En	Location *	LS									
Category	Supplemental			GPS Latitude/Longitude										
				Start	End									
Item	DWR UCIP Field Study			38.425514 °	38.425514 °									
				-121.530970 °	-121.530970 °									
DWR ID														
Action/Comments														
Inspector Comments: FS_ID:15728 DS_ID:22806 EP_NO: N/A FS_HLM: 0.902 Repair Type: Non-Urgent Crossing Status: Found UCIP Comments: Pipe abandoned and should be done so properly. FIELD_STRUCT_DESC: 2 of 6: *Abandoned* 3.5-inch pipe through levee 2.5 feet below crown. Pipe visible in concrete well on LS shoulder and likely in covered concrete well on WS shoulder. FS Date: 07/12/2013

Pipes visible in concrete well on LS shoulder.

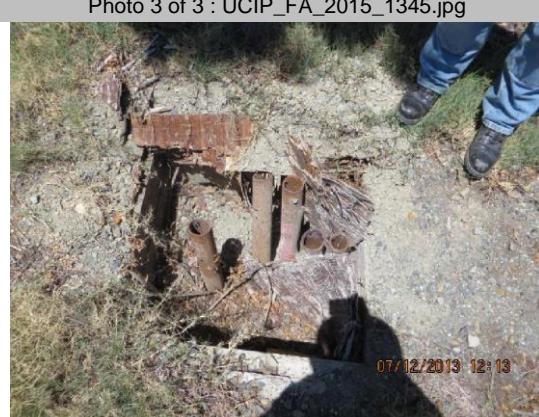
Pipes visible in concrete well on LS shoulder.

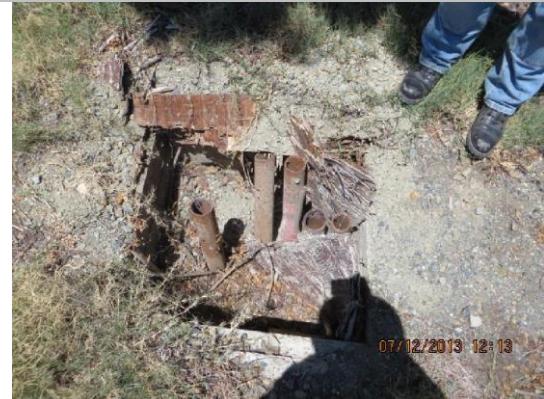
Photo 1 of 3 : UCIP_FA_2015_1342.jpg

LM Start	0.90	Rating **	M	Issue No.	49										
LM End	0.90	Issue Type +	En	Location *	LS										
Category	Supplemental		GPS Latitude/Longitude												
			Start	End											
Item	DWR UCIP Field Study		38.425514 °	38.425514 °											
			-121.530970 °	-121.530970 °											
DWR ID															
Action/Comments															
Inspector Comments: FS_ID:15727 DS_ID:22799 EP_NO: N/A FS_HLM: 0.902 Repair Type: Non-Urgent Crossing Status: Found

Pipes in concrete well on LS shoulder.

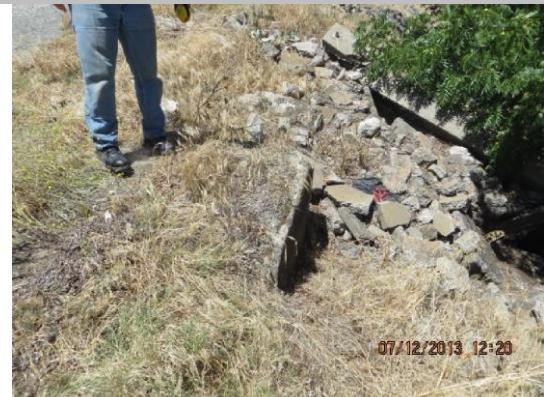
Photo 2 of 3 : UCIP_FA_2015_1475.jpg

Assumed pipes inside concrete well on WS shoulder at same location.

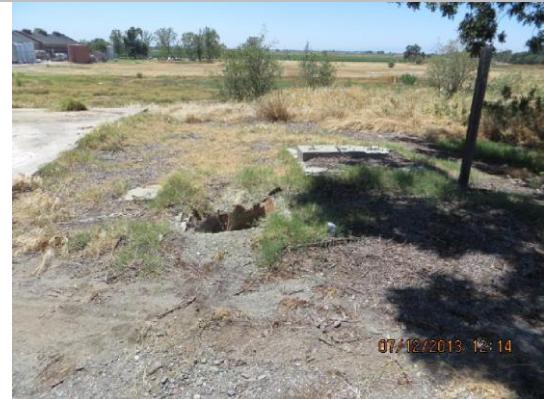
Photo 3 of 3 : UCIP_FA_2015_1476.jpg

Pipes in concrete well on LS shoulder.

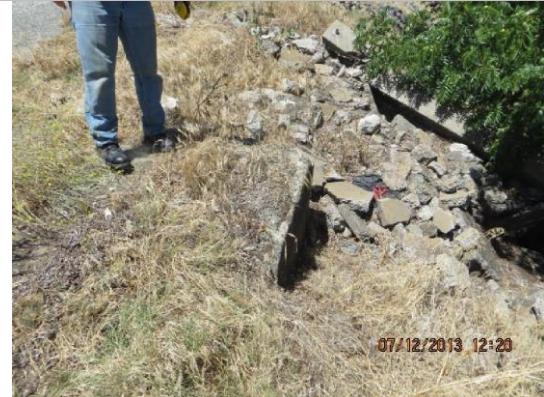
Photo 1 of 3 : UCIP_FA_2015_1166.jpg

LM Start	0.90	Rating **	M	Issue No.	50									
LM End	0.90	Issue Type +	En	Location *	LS									
Category	Supplemental			GPS Latitude/Longitude										
				Start	End									
Item	DWR UCIP Field Study			38.425514 °	38.425514 °									
				-121.530970 °	-121.530970 °									
DWR ID														
Action/Comments														
Inspector Comments: FS_ID:16386 DS_ID:22810 EP_NO: N/A FS_HLM: 0.902 Repair Type: Non-Urgent Crossing Status: Found UCIP Comments: Pipe abandoned and should be done so properly. FIELD_STRUCT_DESC: 6 of 6: *Abandoned* 3.5-inch pipe through levee 2.5 feet below crown. Pipe visible in concrete well on LS shoulder. FS Date: 07/12/2013

Assumed pipes are visible in concrete well on WS shoulder. Soil covers lid on concrete well.

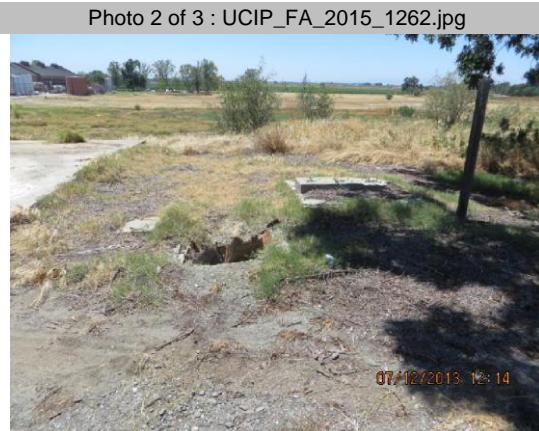
Pipes visible in concrete well on LS shoulder.

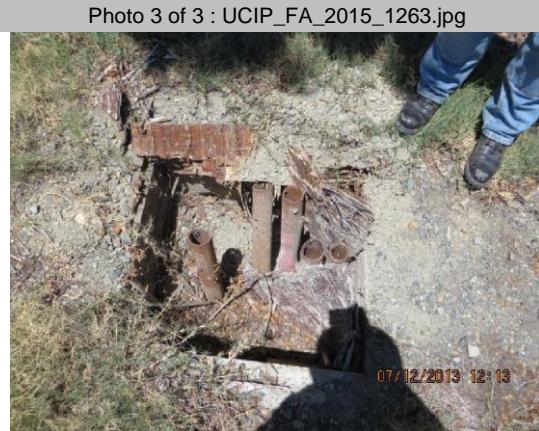
Pipes visible in concrete well on LS shoulder.

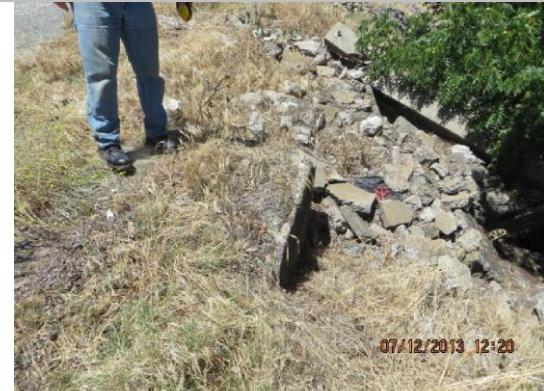
Photo 1 of 3 : UCIP_FA_2015_1163.jpg

LM Start	0.90	Rating **	M	Issue No.	51										
LM End	0.90	Issue Type +	En	Location *	LS										
Category	Supplemental		GPS Latitude/Longitude												
			Start	End											
Item	DWR UCIP Field Study		38.425514 °	38.425514 °											
			-121.530970 °	-121.530970 °											
DWR ID															
Action/Comments															
Inspector Comments: FS_ID:16385 DS_ID:22809 EP_NO: N/A FS_HLM: 0.902 Repair Type: Non-Urgent Crossing Status: Found

Pipe assumed to be in concrete vault on WS shoulder.

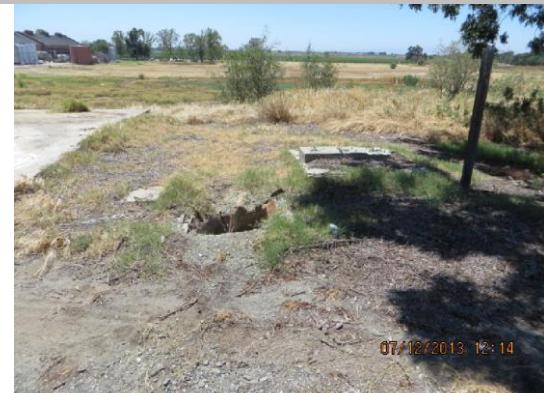
Photo 2 of 3 : UCIP_FA_2015_1164.jpg

Pipe in concrete vault on LS shoulder.

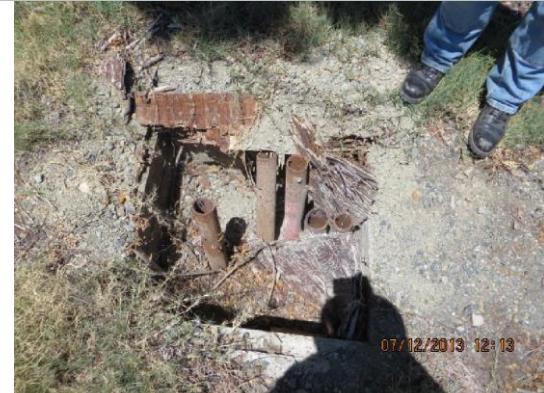
Photo 3 of 3 : UCIP_FA_2015_1165.jpg

Pipe in concrete vault on LS shoulder.

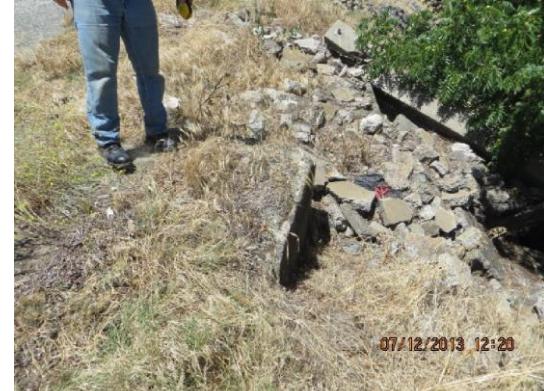
Photo 1 of 3 : UCIP_FA_2015_1105.jpg

LM Start	0.90	Rating **	M	Issue No.	52										
LM End	0.90	Issue Type +	En	Location *	LS										
Category	Supplemental		GPS Latitude/Longitude												
			Start	End											
Item	DWR UCIP Field Study		38.425514 °	38.425514 °											
			-121.530970 °	-121.530970 °											
DWR ID															
Action/Comments															
Inspector Comments: FS_ID:16384 DS_ID:22807 EP_NO: N/A FS_HLM: 0.902 Repair Type: Non-Urgent Crossing Status: Found

Pipe assumed to be in concrete well on WS shoulder.

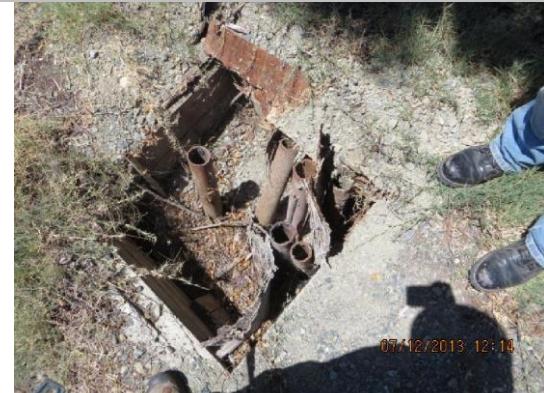
Photo 3 of 3 : UCIP_FA_2015_1162.jpg

Pipe in concrete vault on WS shoulder.

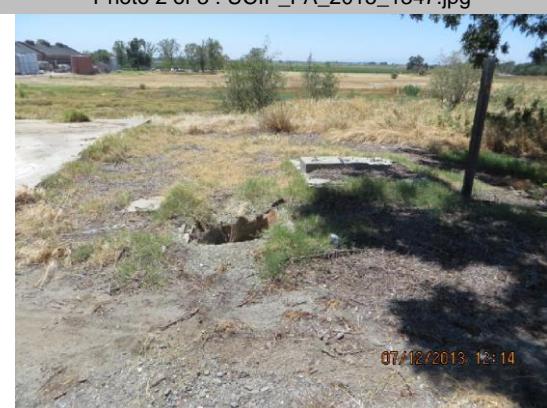
LM Start	0.90	Rating **	M	Issue No.	53		
LM End	0.90	Issue Type +	En	Location *	LS		
Category	Supplemental			GPS Latitude/Longitude			
				Start	End		
Item	DWR UCIP Field Study			38.425514 °	38.425514 °		
				-121.530970 °	-121.530970 °		
DWR ID	Action/Comments						
	Inspector Comments: FS_ID:15733 DS_ID:22808 EP_NO: N/A FS_HLM: 0.902 Repair Type: Non-Urgent Crossing Status: Found

Pipe in concrete well on LS shoulder.

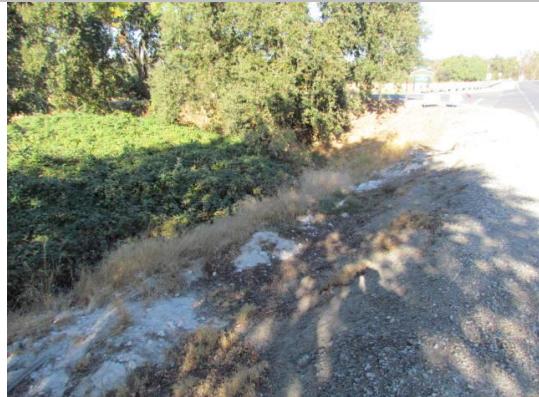
Photo 1 of 3 : FA_2015_RD0999_235_16_20151106_00031.jpg

LM Start	1.04	Rating **	U	Issue No.	16																			
LM End	1.04	Issue Type +	Ma	Location *	LS																			
Category Earthen Levee				GPS Latitude/Longitude																				
				Start	End																			
Item Vegetation				38.427295 °	38.427295 °																			
				-121.532164 °	-121.532164 °																			
DWR ID	DWR_RD0999_04_f_2012_16																							
Action/Comments																								
Remove the wild growth other than native grasses from the levee slopes. Inspector Comments: Blackberries blocking view of landward toe.

Looking northwest at dense vines at landward toe. Fall 2015

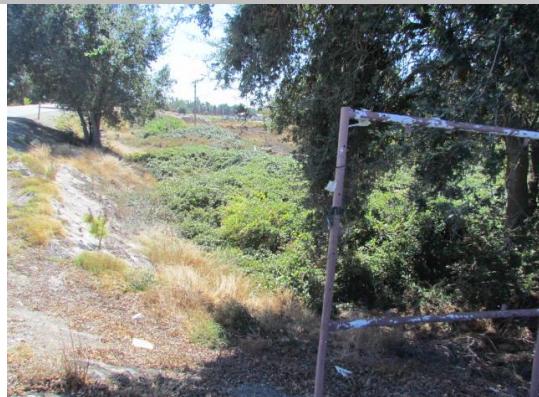
Photo 2 of 3 : FA_2015_RD0999_235_16_20150914_00014.jpg

Looking southwest at dense berry vines at landward toe. 2013

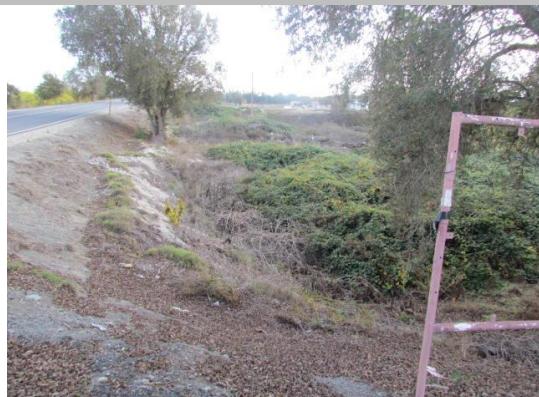
Photo 3 of 3 : FA_2015_RD0999_235_16_20150914_00015.jpg

Looking south at dense berryvines on landside toe. 2012

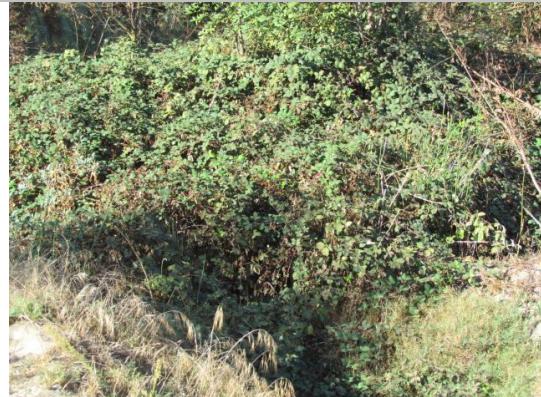
Photo 1 of 3 : FA_2015_RD0999_235_5_20151106_00032.jpg

LM Start	1.15	Rating **	U	Issue No.	5										
LM End	1.15	Issue Type +	Ma	Location *	LS										
Category	Earthen Levee			GPS Latitude/Longitude											
				Start	End										
Item	Vegetation			38.428823 °	38.428823 °										
				-121.532885 °	-121.532885 °										
DWR ID	DWR_RD0999_04_s_2012_5														
Action/Comments															
Remove the wild growth other than native grasses from the levee slopes. Inspector Comments: Berry vines and wild roses on landside toe.

Looking at dense vines at landward toe. Fall 2015.

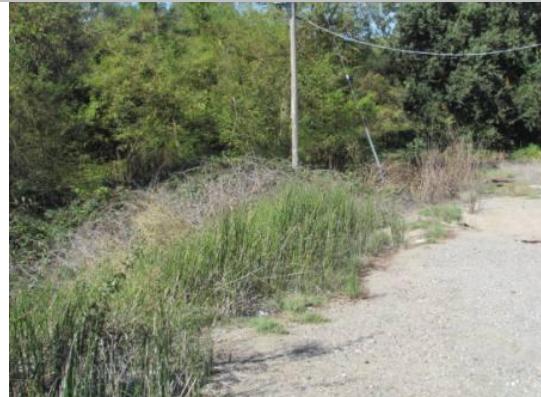
Photo 2 of 3 : FA_2015_RD0999_235_5_20150914_00002.jpg

Looking north at dense vegetation on landside slope near ramp.

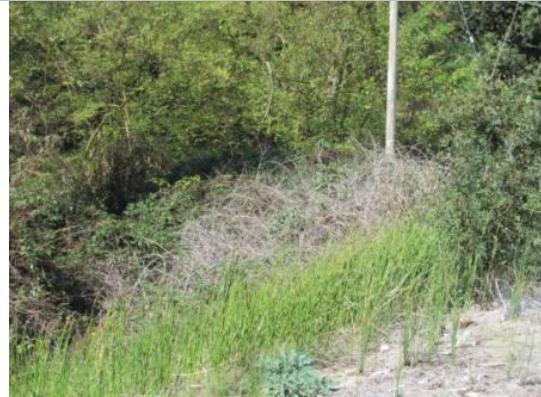
Photo 3 of 3 : FA_2015_RD0999_235_5_20150914_00003.jpg

Looking northwest at dense wild roses and berry vines on landside toe near ramp.

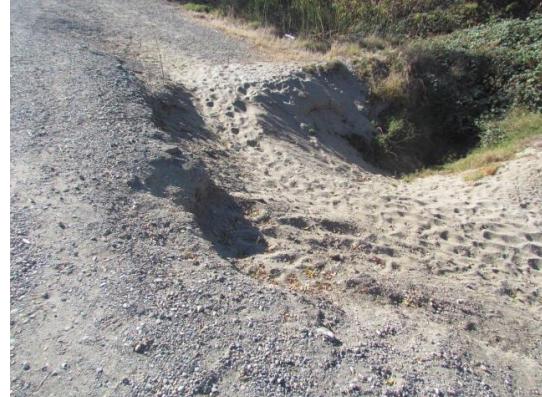
Photo 1 of 3 : FA_2015_RD0999_235_40_20151106_00033.jpg

LM Start	1.16	Rating **	U	Issue No.	40							
LM End	1.16	Issue Type +	Ma	Location *	LS							
Category	Earthen Levee		GPS Latitude/Longitude									
			Start	End								
Item	Erosion / Bank Caving		38.428877 °	38.428877 °	-121.532922 °	-121.532922 °						
DWR ID	DWR_RD0999_04_f_2015_40											
Action/Comments												
Schedule repair of erosion site prior to the next inspection. Inspector Comments: Large hole and erosion on landward shoulder, slope and toe.

Looking southwest at shoulder erosion and caving at landward slope and toe.

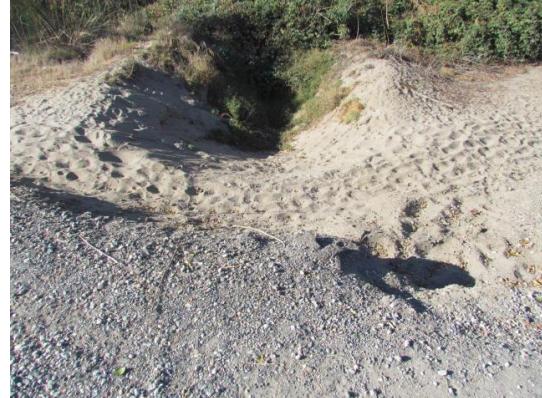
Photo 2 of 3 : FA_2015_RD0999_235_40_20151106_00034.jpg

Looking west at caving at landward slope and toe.

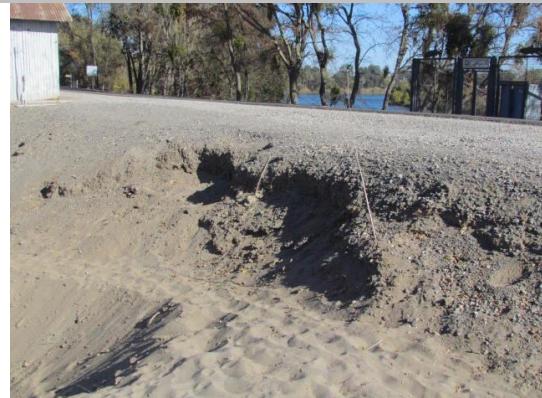
Photo 3 of 3 : FA_2015_RD0999_235_40_20151106_00035.jpg

Looking east at erosion on landward shoulder.

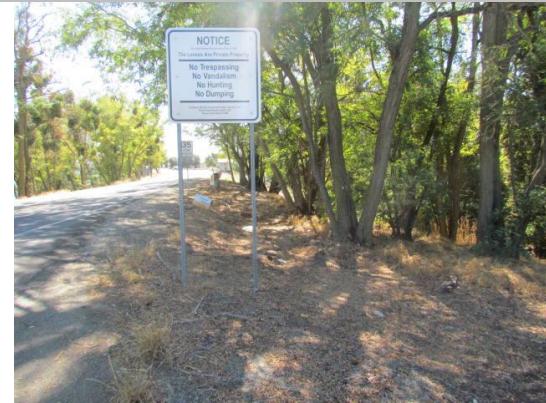
Photo 1 of 1 : FA_2015_RD0999_235_22_20150914_00018.jpg

LM Start	1.20	Rating **	M	Issue No.	22							
LM End	1.22	Issue Type +	Ma	Location *	LS							
Category	Earthen Levee			GPS Latitude/Longitude								
				Start	End							
Item	Trim / Thin Trees			○	○	○						
DWR ID	DWR_RD0999_04_f_2013_22											
Action/Comments												
Trim and thin trees to allow visibility of the ground and room to flood fight.

Looking south at dense trees on landward slope.

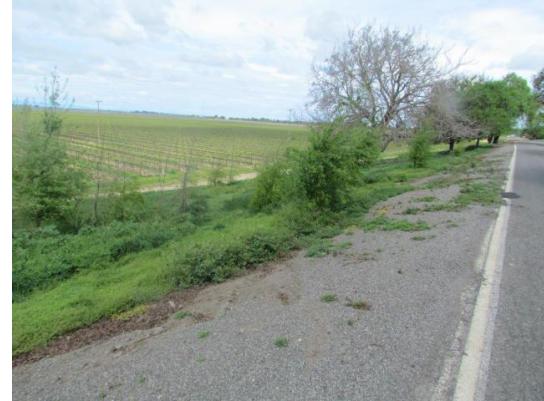
Photo 1 of 1 : FA_2015_RD0999_236_178_20150914_00112.jpg

LM Start	0.05	Rating **	M	Issue No.	178										
LM End	0.05	Issue Type +	Ma	Location *	LS										
Category	Earthen Levee			GPS Latitude/Longitude											
				Start	End										
Item	Trim / Thin Trees			38.333308 °	38.333308 °										
				-121.584494 °	-121.584494 °										
DWR ID	DWR_RD0999_05_s_2015_178														
Action/Comments															
Thin trees to allow visibility of the ground and room to flood fight. Inspector Comments: Remove trees under an inch in diameter on landward slope. Don't allow young trees to get established.

Looking at typical view of young oak trees on landward slope. (Spring 2015)

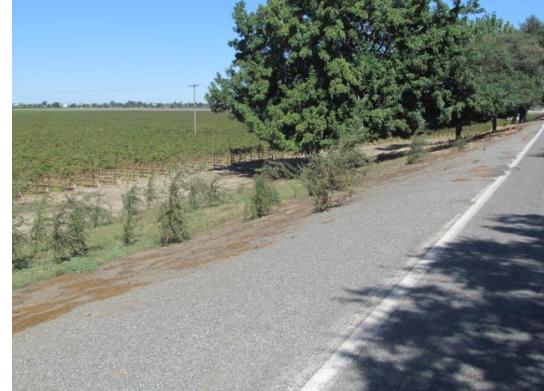
Photo 1 of 1 : FA_2015_RD0999_236_72_20150914_00066.jpg

LM Start	0.10	Rating **	A/W	Issue No.	72										
LM End	0.10	Issue Type +	Ma	Location *	LS										
Category	Earthen Levee			GPS Latitude/Longitude											
				Start	End										
Item	Trim / Thin Trees			°	°										
				°	°										
DWR ID	DWR_RD0999_05_f_2013_72														
Action/Comments															
Trim and thin trees to allow visibility of the ground and room to flood fight. Inspector Comments: Remove small oak trees from landward slope before trees are established.

Looking west at small oak trees on landward slope.

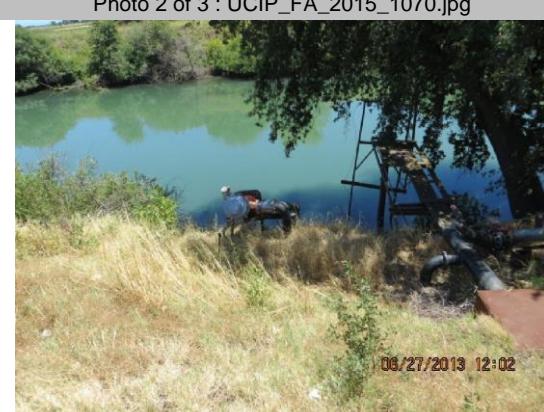
2nd Pump visible on WS slope.

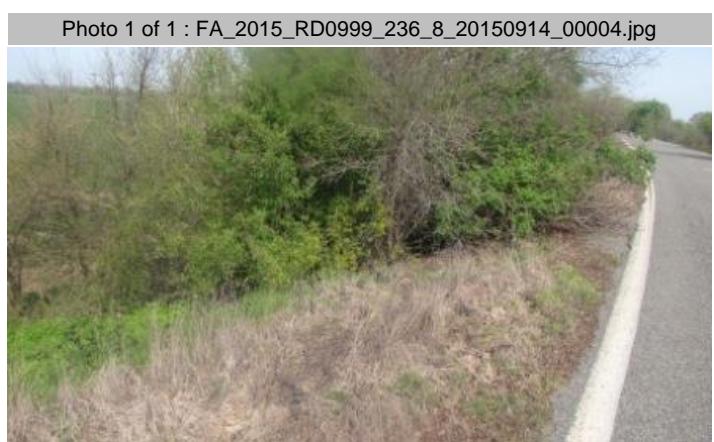
LM Start	0.37	Rating **	U	Issue No.	8									
LM End	0.45	Issue Type +	En	Location *	LS									
Category	Earthen Levee			GPS Latitude/Longitude										
				Start	End									
Item	Trim / Thin Trees			38.337654 °	38.338790 °									
				-121.582427 °	-121.582184 °									
DWR ID	DWR_RD0999_05_s_2012_8													
Action/Comments														
Trim and thin trees to allow visibility of the ground and room to flood fight.

Looking north at dense vegetation on landside slope and toe.

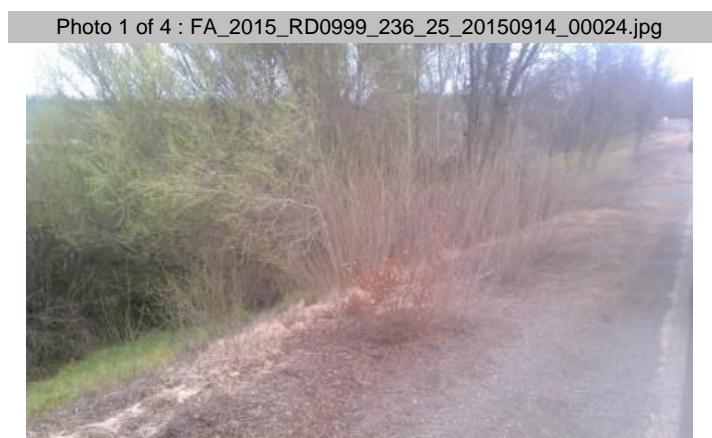
Photo 1 of 4 : FA_2015_RD0999_236_25_20150914_00024.jpg

LM Start	0.40	Rating **	U	Issue No.	25													
LM End	0.44	Issue Type +	Ma	Location *	LS													
Category	Earthen Levee			GPS Latitude/Longitude														
				Start	End													
Item	Vegetation			38.338075 °	38.338688 °													
				-121.582322 °	-121.582193 °													
DWR ID	DWR_RD0999_05_s_2012_25																	
Action/Comments																		
Remove the wild growth other than native grasses from the levee slopes.																		
Inspector Comments: Elderberries within vegetation area.

Looking northwest at dense vegetation on landside slope and toe.

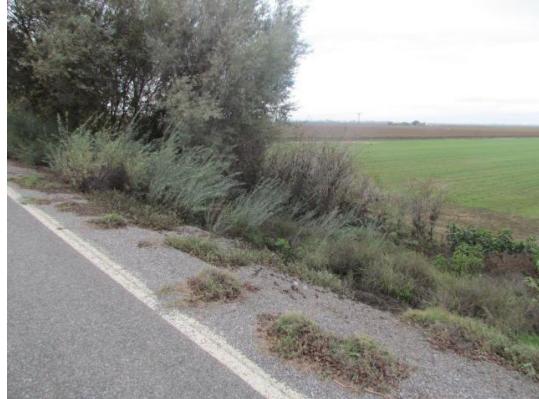
Photo 2 of 4 : FA_2015_RD0999_236_25_20150914_00025.jpg

Looking southwest at vegetation on landside slope and toe. (Fall 2012)

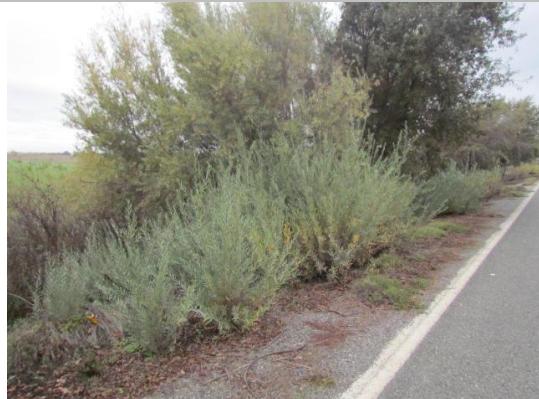
Photo 3 of 4 : FA_2015_RD0999_236_25_20150914_00026.jpg

Looking northwest at vegetation on landside shoulder. (Fall 2012)

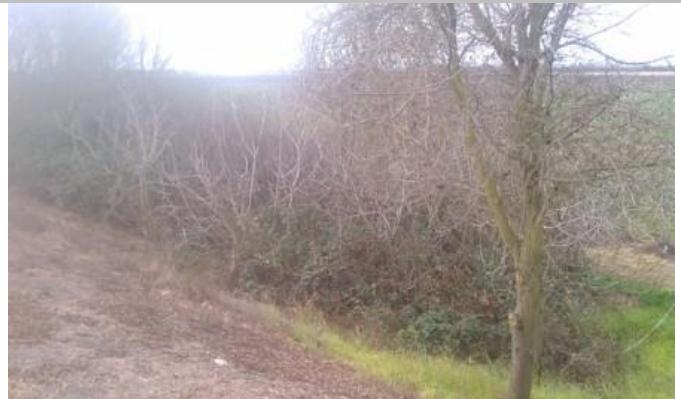
Photo 4 of 4 : FA_2015_RD0999_236_25_20150914_00027.jpg

Looking southwest at dense berry vines on landside toe.

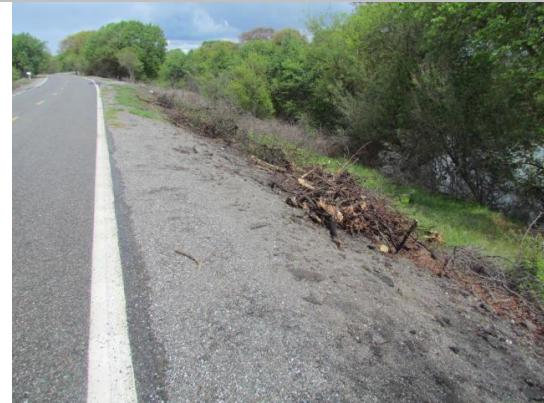
Photo 1 of 1 : FA_2015_RD0999_236_26_20150914_00028.jpg

LM Start	0.44	Rating **	A/W	Issue No.	26							
LM End	0.45	Issue Type +	Ma	Location *	WS							
Category	Earthen Levee		GPS Latitude/Longitude									
			Start	End								
Item	Encroachments		38.338647 °	38.338868 °	-121.582217 °	-121.582163 °						
DWR ID	DWR_RD0999_05_s_2012_26											
Action/Comments												
Prunings

Looking northeast at prunings on waterside slope.

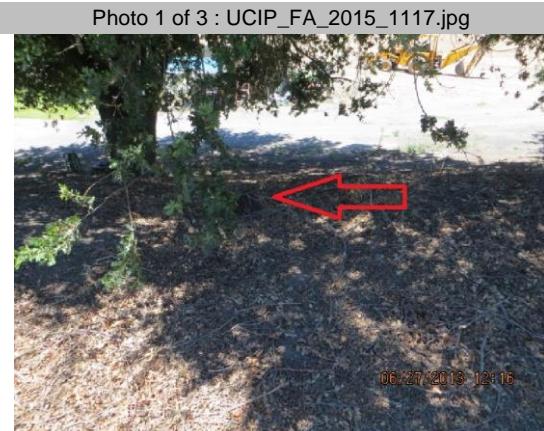
LM Start	0.50	Rating **	M	Issue No.	212											
LM End	0.50	Issue Type +	En	Location *	LS											
Category				GPS Latitude/Longitude												
				Start	End											
Item				DWR UCIP Field Study	38.339607 °	38.339607 °										
					-121.582091 °	-121.582091 °										
DWR ID																
Action/Comments																
Inspector Comments: FS_ID:15413 DS_ID:22840 EP_NO: 6081 FS_HLM: 0.533 Repair Type: Non-Urgent Crossing Status: Found UCIP Comments: Some settlement along LS and WS slopes. Good candidated for video inspection. FIELD_STRUCT_DESC: 10-inch steel pipe through levee 3.3 feet below crown. Pump and butterfly valve in pump house on waterward slope. Vent in 10-inch steel standpipe on LS slope (Permit No. 6081,1968). Replaces an existing 10-inch pipe. FS Date: 06/27/2013

Vent in 10-inch riser on LS slope.

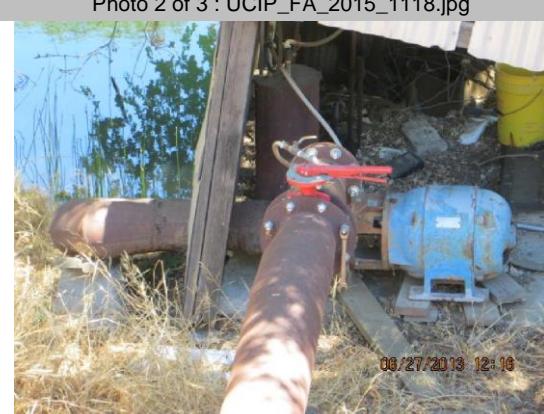
Butterfly valve at pumphouse on WS slope.

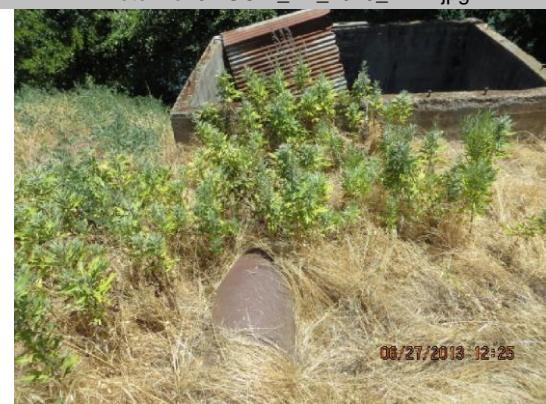
Pipe visible on WS slope.

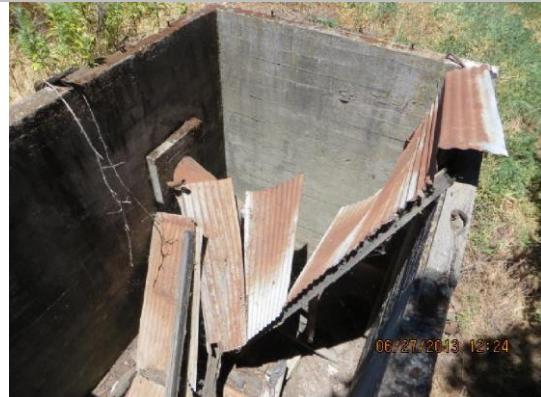
Photo 3 of 3 : UCIP_FA_2015_1122.jpg

Pipe visible inside abandoned pumphouse on WS slope.

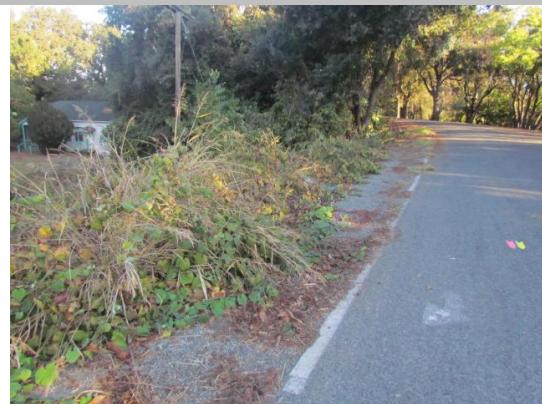
Photo 1 of 1 : FA_2015_RD0999_236_189_20150914_00115.jpg

LM Start	0.68	Rating **	A/W	Issue No.	189									
LM End	0.68	Issue Type +	Ma	Location *	LS									
Category	Earthen Levee			GPS Latitude/Longitude										
				Start	End									
Item	Vegetation			38.342032 °	38.342032 °									
				-121.581372 °	-121.581372 °									
DWR ID	DWR_RD0999_05_f_2014_189													
Action/Comments														
Remove the wild growth other than native grasses from the levee slopes.														
Inspector Comments: Dense wild grapevines on landward slope.

Looking northwest at dense vegetation on landward slope.

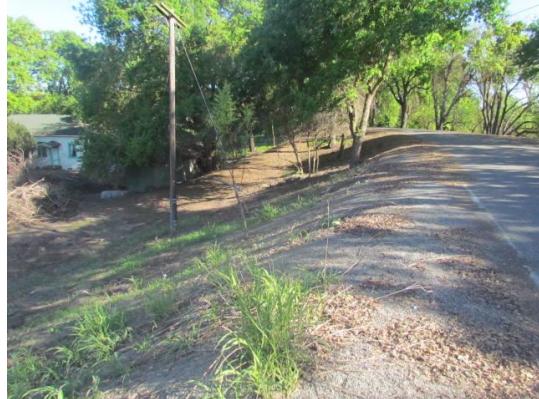
Photo 1 of 6 : FA_2015_RD0999_236_9_20150914_00005.jpg

LM Start	0.69	Rating **	A/W	Issue No.	9										
LM End	0.71	Issue Type +	Ma	Location *	LS										
Category	Earthen Levee		GPS Latitude/Longitude												
			Start	End											
Item	Trim / Thin Trees		38.342180 °	38.342537 °											
			-121.581230 °	-121.581263 °											
DWR ID	DWR_RD0999_05_s_2012_9														
Action/Comments															
Trim and thin trees to allow visibility of the ground and room to flood fight. Inspector Comments: District or landowner trimmed trees to comply with standards.

Looking northwest at landward slope. (Spring 2015)

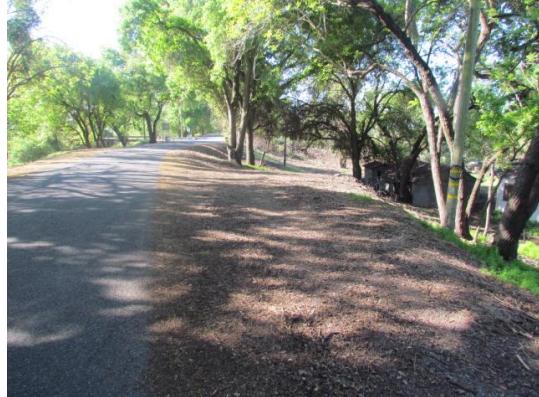
Photo 2 of 6 : FA_2015_RD0999_236_9_20150914_00006.jpg

Looking south at landward slope. (Spring 2015)

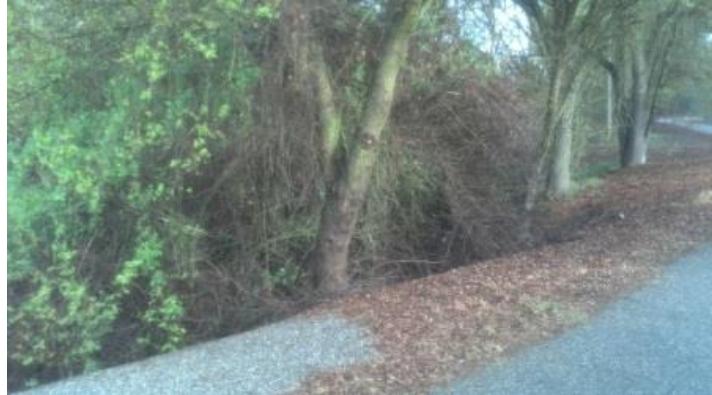
Photo 3 of 6 : FA_2015_RD0999_236_9_20150914_00007.jpg

Looking northwest at dense trees at landside slope and toe. (Spring 2013)

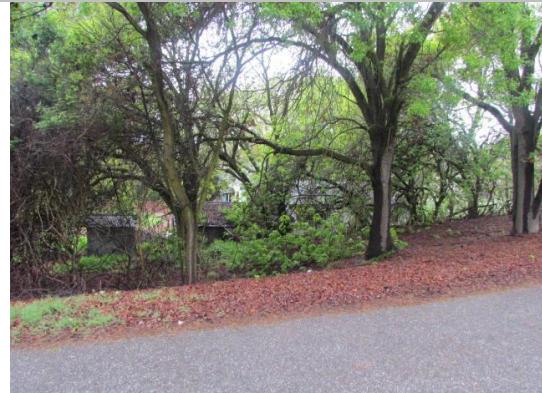
Photo 4 of 6 : FA_2015_RD0999_236_9_20150914_00008.jpg

Looking west at trimmed trees on landside slope. (Spring 2012)

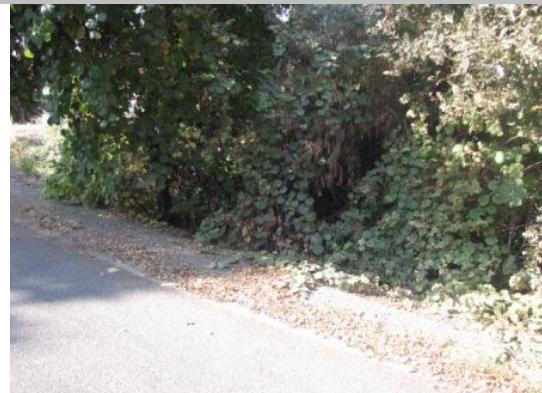
Photo 5 of 6 : FA_2015_RD0999_236_9_20150914_00009.jpg

Looking west at dense trees on landside slope and toe. (Spring 2011)

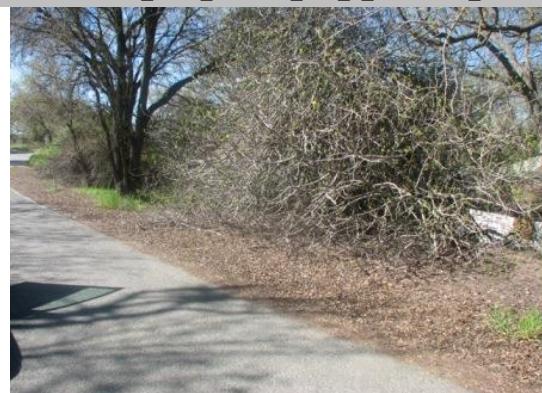
Photo 6 of 6 : FA_2015_RD0999_236_9_20150914_00010.jpg

Front view of dense trees at landside shoulder. (Spring 2011)

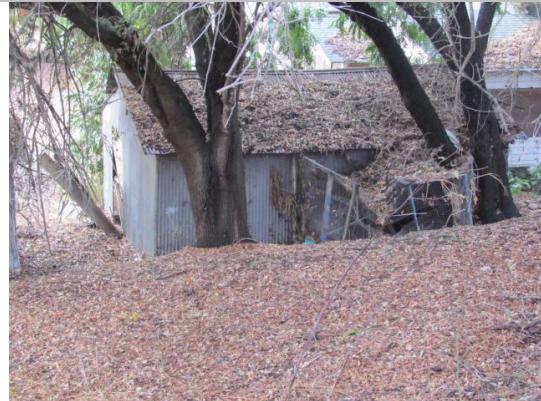
Photo 1 of 1 : FA_2015_RD0999_236_170_20151106_00152.jpg

LM Start	0.70	Rating **	U	Issue No.	170										
LM End	0.70	Issue Type +	En	Location *	LS										
Category	Earthen Levee			GPS Latitude/Longitude											
				Start	End										
Item	Encroachments			38.342288 °	38.342288 °										
				-121.581278 °	-121.581278 °										
DWR ID	DWR_RD0999_05_f_2015_170														
Action/Comments															
Building Inspector Comments: Toolshed at landward toe.

Looking at the toolshed at the landward toe.

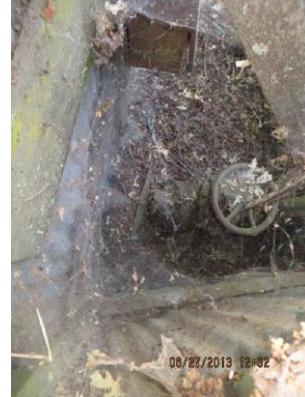
Photo 1 of 2 : UCIP_FA_2015_1299.jpg

LM Start	0.72	Rating **	M	Issue No.	214										
LM End	0.72	Issue Type +	En	Location *	LS										
Category	Supplemental			GPS Latitude/Longitude											
				Start	End										
Item	DWR UCIP Field Study			38.342653 °	38.342653 °										
				-121.581236 °	-121.581236 °										
DWR ID															
Action/Comments															
Inspector Comments: FS_ID:15450 DS_ID:22842 EP_NO: N/A FS_HLM: 0.753 Repair Type: Non-Urgent Crossing Status: Found UCIP Comments: Pipe abandoned and should be done so properly. FIELD_STRUCT_DESC: *Abandoned* 6-inch pipe through levee 11.5 feet below crown. Pump and gate valve in pump house on the waterward slope. 1.5-inch galvanized iron electrical conduit at same location. Originally included in the 1966 O&M manual. FS Date: 06/27/2013

Pipe rusted through at gatevalve inside pumphouse.

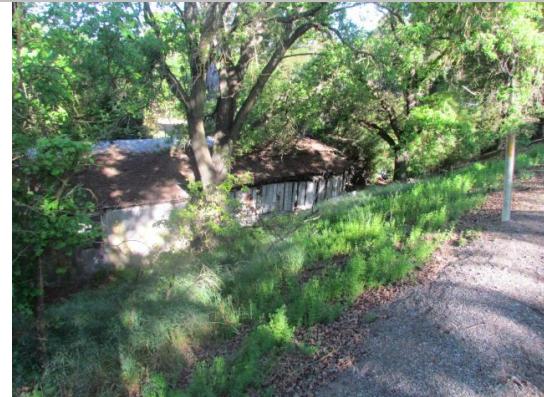
Photo 1 of 2 : FA_2015_RD0999_236_23_20150914_00021.jpg

LM Start	0.77	Rating **	U	Issue No.	23										
LM End	0.77	Issue Type +	En	Location *	LS										
Category	Earthen Levee		GPS Latitude/Longitude												
			Start	End											
Item	Encroachments		38.343358 °	38.343358 °											
			-121.581295 °	-121.581295 °											
DWR ID	DWR_RD0999_05_f_2012_23														
Action/Comments															
Building Inspector Comments: Storage shed at landside toe and within the 10' easement.

Looking northwest at abandoned storage shed at landward toe. (Spring 2015)

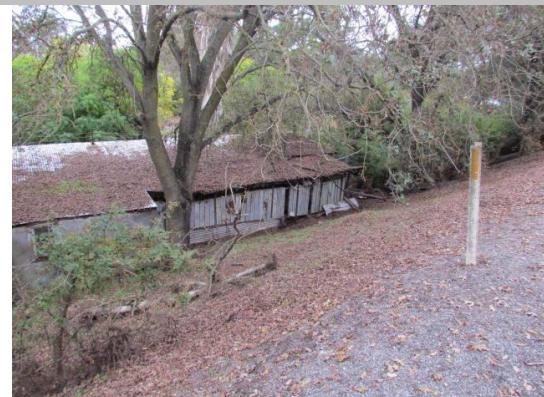
Photo 2 of 2 : FA_2015_RD0999_236_23_20150914_00022.jpg

Looking northwest at storage shed at landside toe and within the 10' easement.

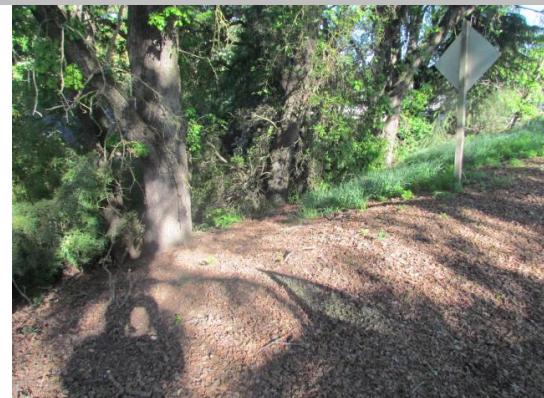
Photo 1 of 2 : FA_2015_RD0999_236_128_20150914_00088.jpg

Looking northwest at untrimmed trees on landward slope. (Spring 2015)

LM Start	0.78	Rating **	M	Issue No.	128										
LM End	0.78	Issue Type +	Ma	Location *	LS										
Category	Earthen Levee		GPS Latitude/Longitude												
			Start	End											
Item	Trim / Thin Trees		38.343495 °	38.343495 °											
			-121.581282 °	-121.581282 °											
DWR ID	DWR_RD0999_05_s_2012_128														
Action/Comments															
Trim and thin trees to allow visibility of the ground and room to flood fight.

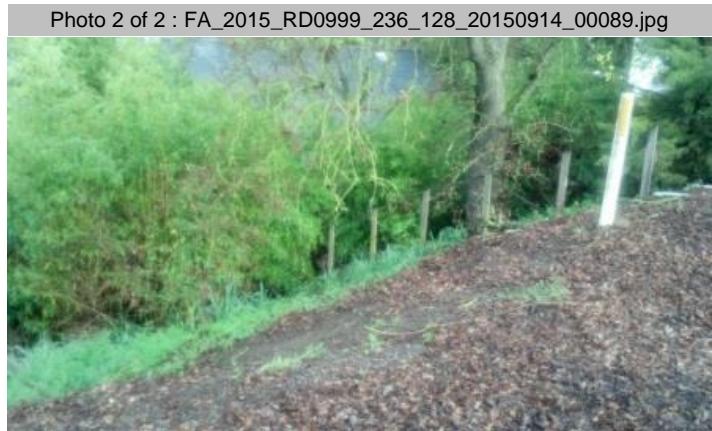
Looking at dense trees on landside slope and toe.

LM Start	0.78	Rating **	M	Issue No.	128 (cont)															
LM End	0.78	Issue Type +	Ma	Location *	LS															
Category	Earthen Levee			GPS Latitude/Longitude																
				Start	End															
Item	Trim / Thin Trees			38.343495 °	38.343495 °															
				-121.581282 °	-121.581282 °															
DWR ID	DWR_RD0999_05_s_2012_128																			
Action/Comments																				
Trim and thin trees to allow visibility of the ground and room to flood fight.

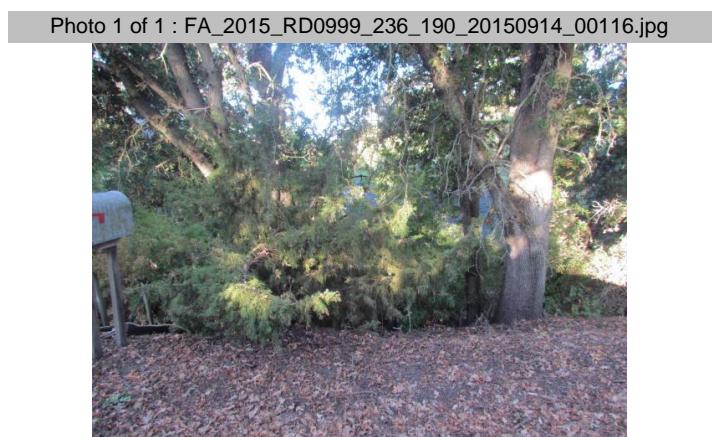
Looking west at dense vegetation on landward slope and toe.

LM Start	0.79	Rating **	U	Issue No.	190															
LM End	0.79	Issue Type +	Ma	Location *	LS															
Category	Earthen Levee			GPS Latitude/Longitude																
				Start	End															
Item	Trim / Thin Trees			38.343606 °	38.343606 °															
				-121.581279 °	-121.581279 °															
DWR ID	DWR_RD0999_05_f_2014_190																			
Action/Comments																				
Trim and thin trees to allow visibility of the ground and room to flood fight.

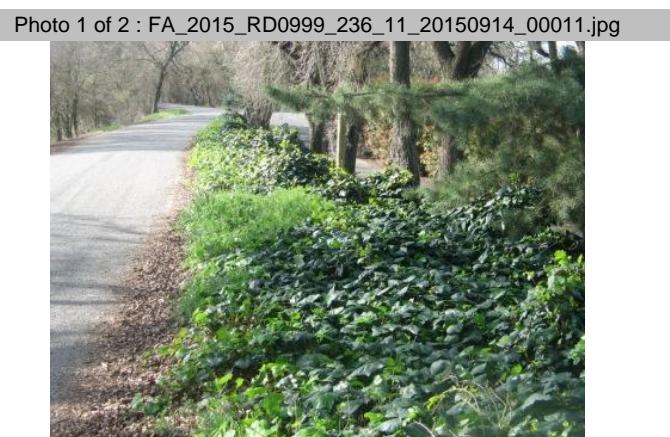
LM Start	0.80	Rating **	U	Issue No.	11															
LM End	0.90	Issue Type +	En	Location *	LS															
Category	Earthen Levee			GPS Latitude/Longitude																
				Start	End															
Item	Vegetation			38.343825 °	38.345215 °															
				-121.581133 °	-121.580728 °															
DWR ID	DWR_RD0999_05_s_2012_11																			
Action/Comments																				
Landscaping

View of landscaping (Ivy) looking upstream.

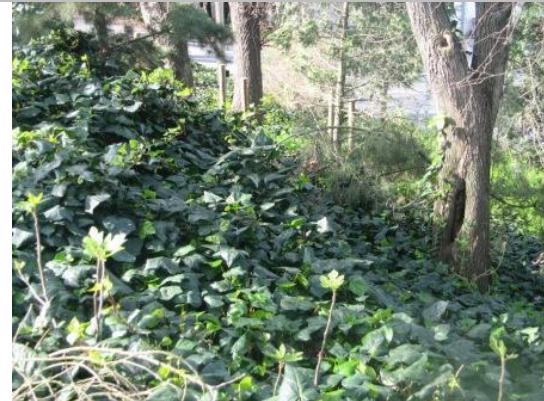
Photo 2 of 2 : FA_2015_RD0999_236_11_20150914_00012.jpg

View of landscaping (Ivy) blocking view of landside slope from.

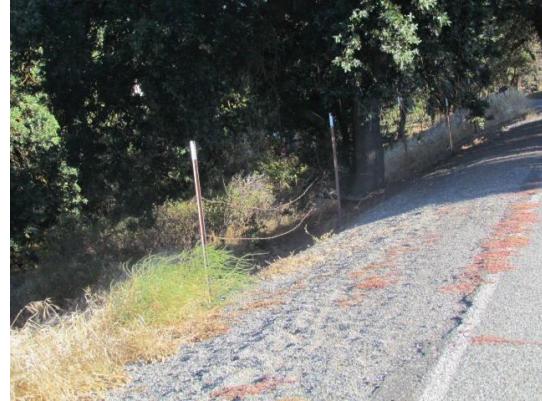
Photo 1 of 1 : FA_2015_RD0999_236_136_20150914_00095.jpg

LM Start	0.99	Rating **	M	Issue No.	136						
LM End	1.02	Issue Type +	En	Location *	LS						
Category	Earthen Levee			GPS Latitude/Longitude							
				Start	End						
Item	Encroachments			°	°						
DWR ID	DWR_RD0999_05_f_2013_136						Action/Comments				
Fence Inspector Comments: Fencing on landward slope.

Looking northwest at fence on landward slope.

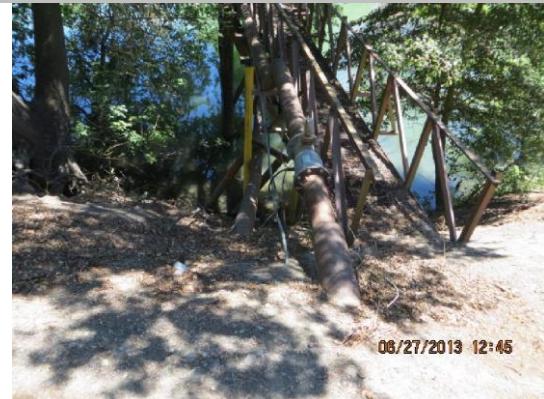
Photo 1 of 2 : UCIP_FA_2015_1355.jpg

LM Start	1.13	Rating **	M	Issue No.	215									
LM End	1.13	Issue Type +	En	Location *	LS									
Category	Supplemental			GPS Latitude/Longitude										
				Start	End									
Item	DWR UCIP Field Study		38.348113 °	38.348113 °										
			-121.578841 °	-121.578841 °										
DWR ID														
Action/Comments														
Inspector Comments: FS_ID:16336 DS_ID:23964 EP_NO: N/A FS_HLM: 1.165 Repair Type: Non-Urgent Crossing Status: Found UCIP Comments: Pipe appears abandoned and should be removed. FIELD_STRUCT_DESC: *Abandoned*10-inch steel irrigation pipe through levee 6.5-feet below crown. Pipe extends under metal walkway on WS shoulder. FS Date: 06/27/2013

Pipe visible beneath 10-inch pipe that is currently in use. No connection.

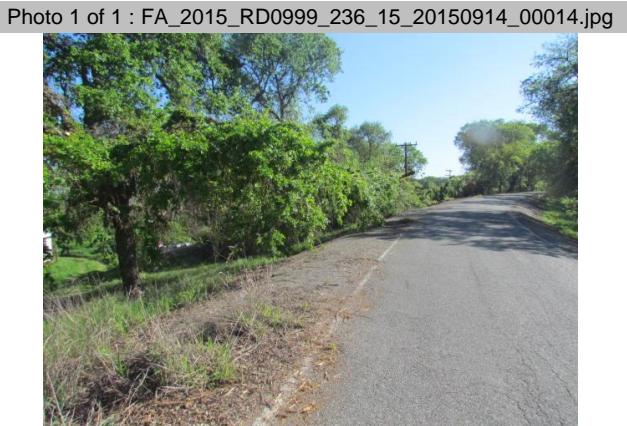
Looking north at untrimmed trees on landward slope and toe. (Spring 2015)

LM Start	1.15	Rating **	M	Issue No.	15									
LM End	1.19	Issue Type +	Ma	Location *	LS									
Category	Earthen Levee			GPS Latitude/Longitude										
				Start	End									
Item	Trim / Thin Trees			38.348237 °	38.348328 °									
				-121.578440 °	-121.577735 °									
DWR ID	DWR_RD0999_05_s_2012_15													
Action/Comments														
Trim trees to at least five feet above ground level.

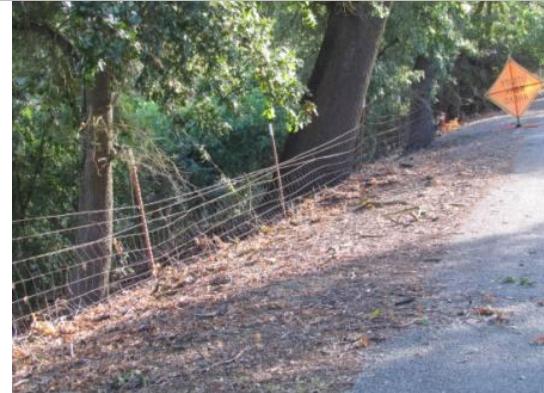
Photo 1 of 1 : FA_2015_RD0999_236_76_20150914_00068.jpg

LM Start	1.20	Rating **	M	Issue No.	76																
LM End	1.22	Issue Type +	En	Location *	LS																
Category	Earthen Levee			GPS Latitude/Longitude																	
				Start	End																
Item	Encroachments			38.348336 °	38.348332 °																
				-121.577621 °	-121.577172 °																
DWR ID	DWR_RD0999_05_s_2012_76																				
Action/Comments																					
Fence Inspector Comments: Fence is located on landside shoulder.

Looking north at fence along landside slope.

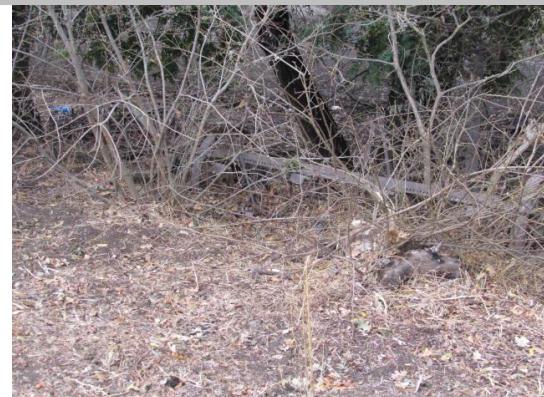
Photo 1 of 1 : FA_2015_RD0999_236_171_20151106_00156.jpg

LM Start	1.25	Rating **	M	Issue No.	171																
LM End	1.25	Issue Type +	En	Location *	LS																
Category	Earthen Levee			GPS Latitude/Longitude																	
				Start	End																
Item	Encroachments			38.348319 °	38.348319 °																
				-121.576566 °	-121.576566 °																
DWR ID	DWR_RD0999_05_f_2015_171																				
Action/Comments																					
Equipment Inspector Comments: Old farm equipment on landward slope

Looking at farm equipment on landward slope.

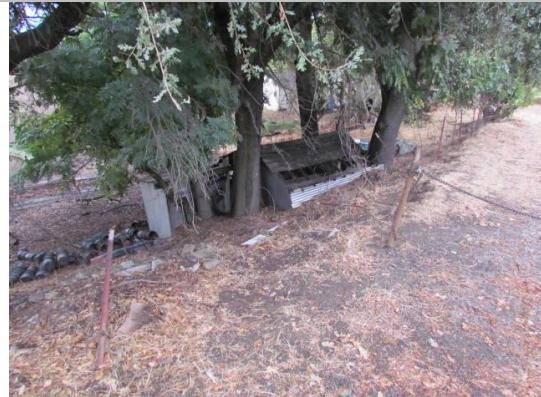
Photo 1 of 3 : FA_2015_RD0999_236_172_20151106_00154.jpg

LM Start	1.27	Rating **	U	Issue No.	172										
LM End	1.27	Issue Type +	En	Location *	LS										
Category	Earthen Levee		GPS Latitude/Longitude												
			Start	End											
Item	Encroachments		38.348304 °	38.348304 °											
			-121.576207 °	-121.576207 °											
DWR ID	DWR_RD0999_05_f_2015_172														
Action/Comments															
Building Inspector Comments: Toolshed excavated into landward toe.

Looking southwest at toolshed at landward toe.

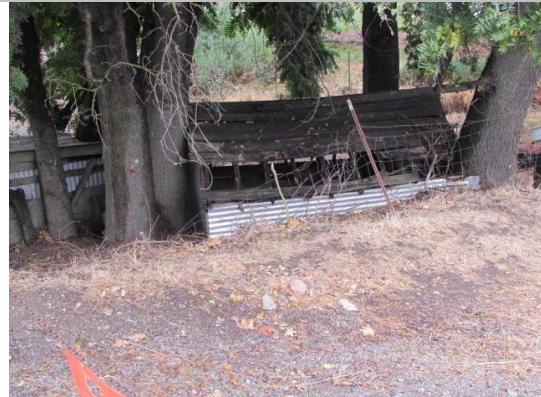
Photo 2 of 3 : FA_2015_RD0999_236_172_20151106_00155.jpg

Looking west at toolshed at landward toe.

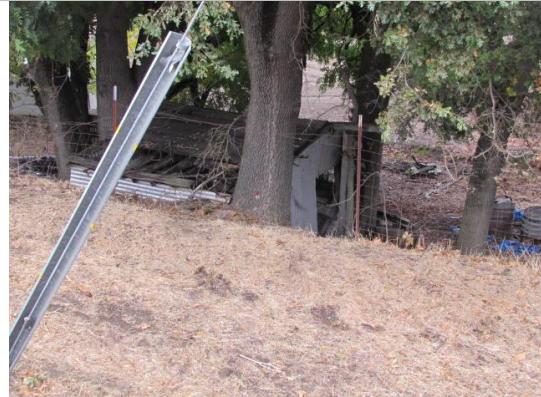
Photo 3 of 3 : FA_2015_RD0999_236_172_20151106_00157.jpg

Looking at northwest at toolshed at landward toe.

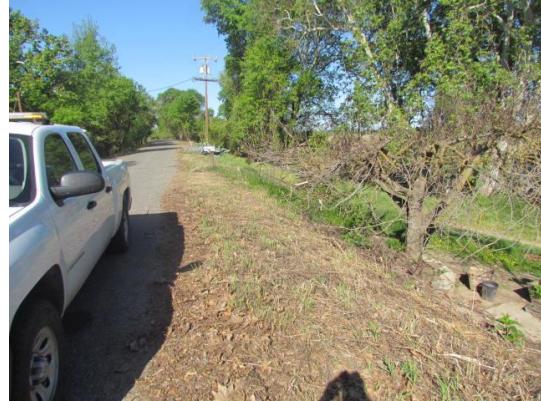
Photo 1 of 3 : FA_2015_RD0999_236_2_20150914_00001.jpg

LM Start	1.30	Rating **	M	Issue No.	2									
LM End	1.36	Issue Type +	En	Location *	LS									
Category	Earthen Levee		GPS Latitude/Longitude											
			Start	End										
Item	Vegetation		38.348267 °	38.348188 °										
			-121.575802 °	-121.574690 °										
DWR ID	DWR_RD0999_05_s_2012_2													
Action/Comments														
Landscaping Inspector Comments: Control landscaping on landward slope. Landowner has trimmed landscaping. But has not removed century plant on landward shoulder.

Looking south at landward slope. (Spring 205)

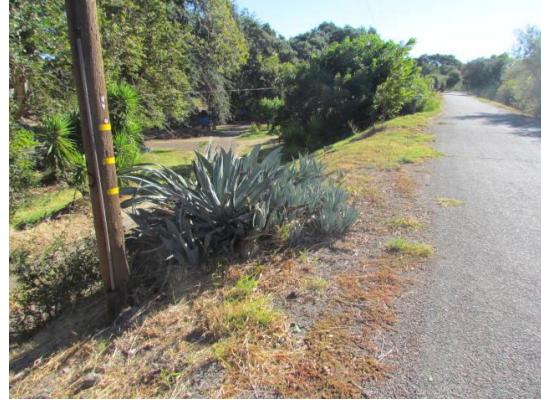
Photo 2 of 3 : FA_2015_RD0999_236_2_20150914_00002.jpg

Looking northwest at landscaping on landward slope.
